# Manhole Inspection Summary

Manhole # S45CC\_011MH

Insp Date: **8/12/08 9:55 AM**

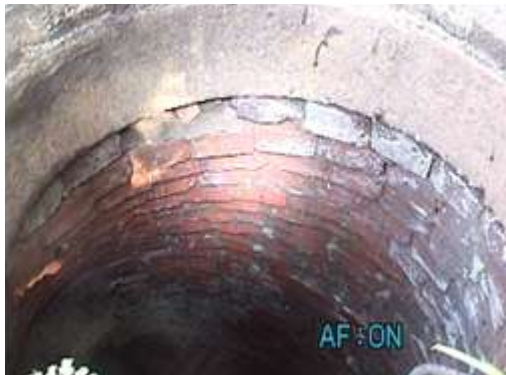
Defect 2

Condition: ☐ Sound ☐ Cracked ☐ Root Intrusion ☒ **Loose Brick** ☐ Deteriorated

loose brick

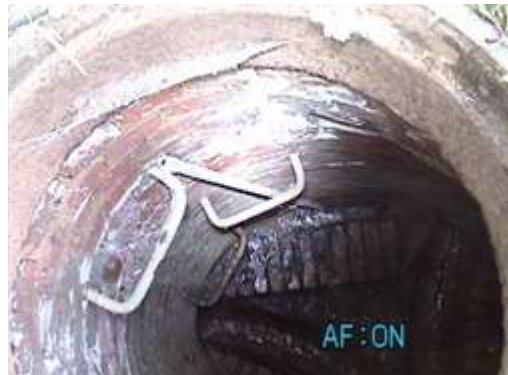
Defect 1

Infiltration: ☐ None ☐ Joint ☐ Cracks ☒ **Mortar** ☐ Roots ☐ Wall

infiltration

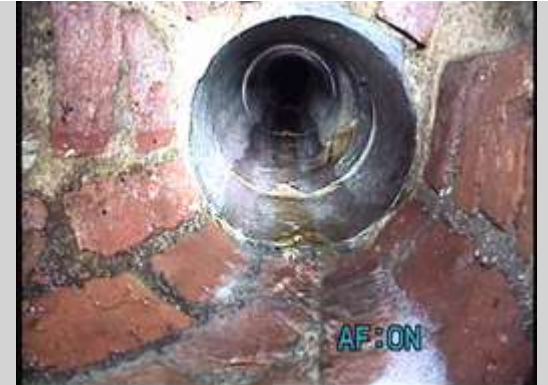
12 O'Clock Outflow

Pipe Height: **8.4** (in.) Rod and Bar (Angled)  
Pipe Material: **Clay** ☐ Pipe Lined  
Invert Depth: **7.25** (ft.) Flow Characteristics: **Fast**  
Deposits: ☒ None ☐ Mud ☐ Sludge ☐ Debris ☐ Grease  
Silt Depth: (in.) Deposits Extent:  
Infiltration: **None** Pipe Seal Cond: **Sound**

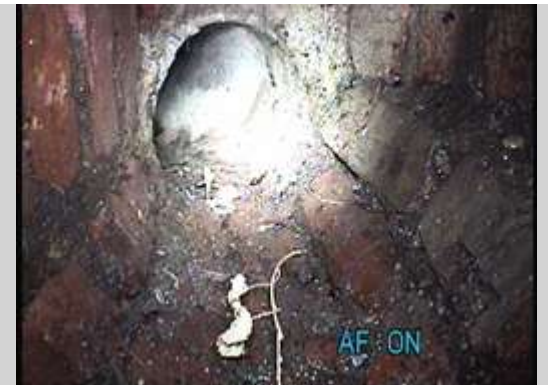
5 O'Clock Inflow

Pipe Height: **8.4** (in.) Rod and Bar (Angled)  
Pipe Material: **Clay** ☐ Pipe Lined  
Invert Depth: **7.05** (ft.) Flow Characteristics: **Fast**  
Deposits: ☒ None ☐ Mud ☐ Sludge ☐ Debris ☐ Grease  
Silt Depth: (in.) Deposits Extent:  
Infiltration: **None** Pipe Seal Cond: **Sound**

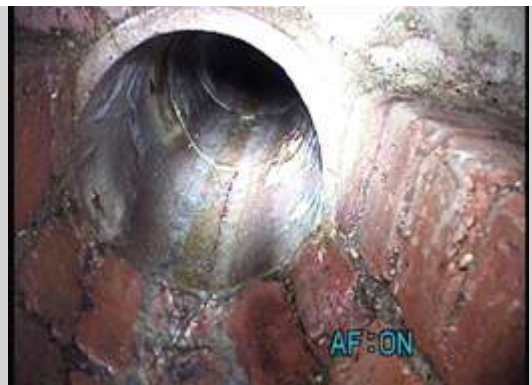
9 O'Clock Inflow

Infiltration: **None** Pipe Seal Cond: **Sound**
